ACTA Virtual Public Meeting

ANSI/TIA-1096-A Non-Compliance Issues (Focus on RJ45)

Sentinel Connector Systems
Bob Brennan and Dave Jeskey

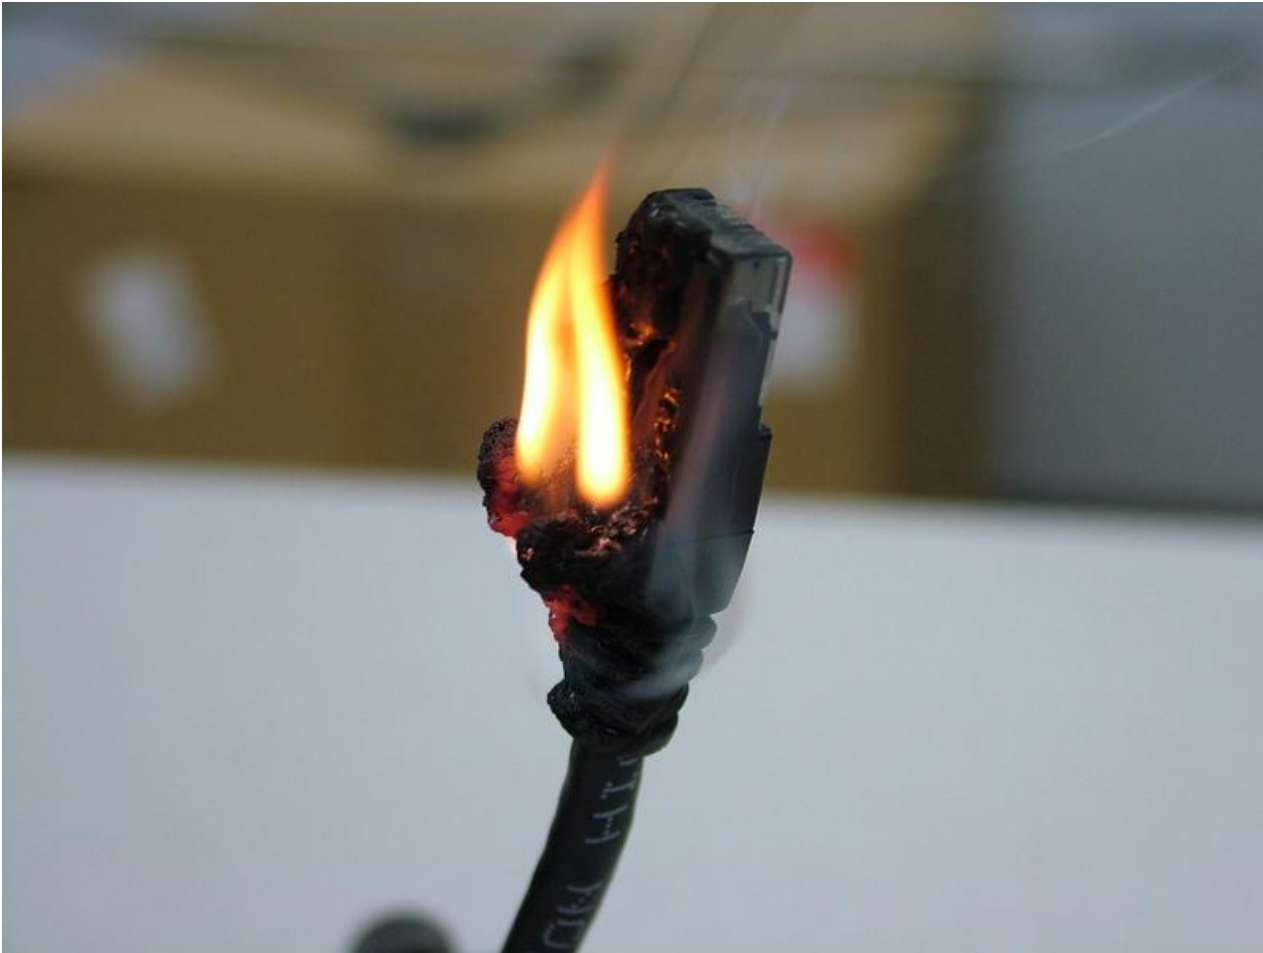
Sub-Standard Material – Violates UL

Use of 94V-2 Material (cheaper) instead of 94V-0

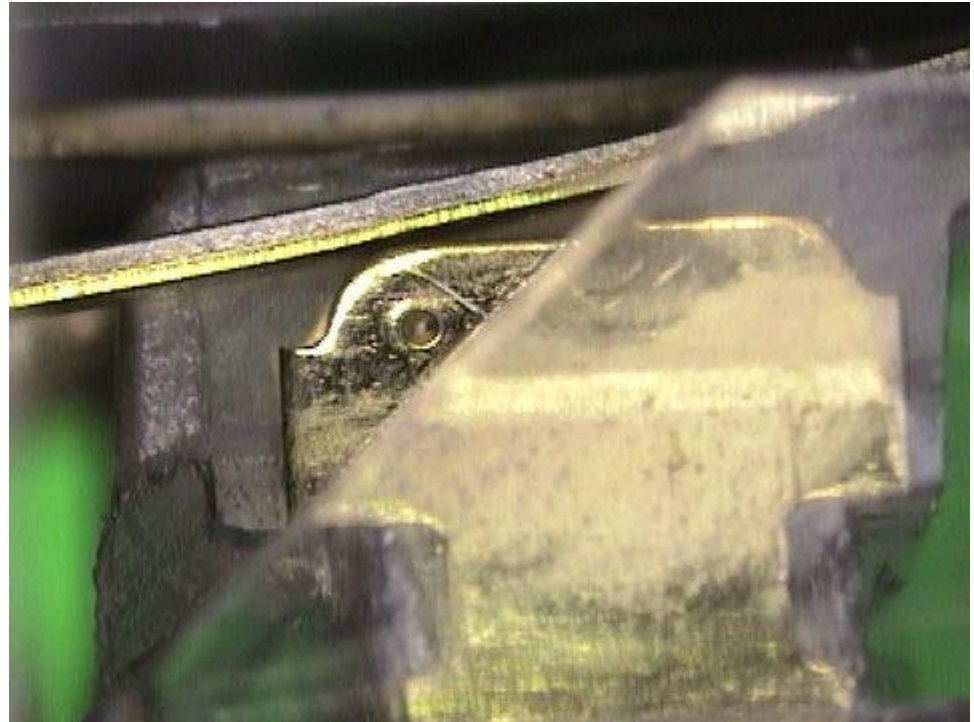
We are hearing about this more and more. Basically, the RJ45 Jack on the Switch is TOO WIDE.

This causes the plastic of the plug (between the contacts) to 'LIFT OFF' from the jack contact resulting in Loss of Signal or Intermittencies.

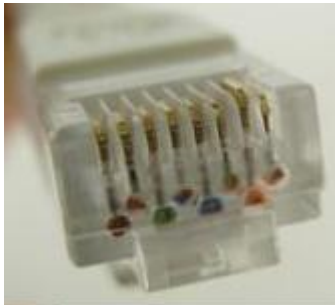
Seeing More and More Blade Depth Issues

2nd Contact From Right
Taken from CI&M Article
